**Report on the November 2003
Ohio EPA Ground Water
Investigation at the
Miller Lumber Site
Pike County, Ohio**

By
David Hunt
OEPA-DDAGW-SEDO
February 13, 2004

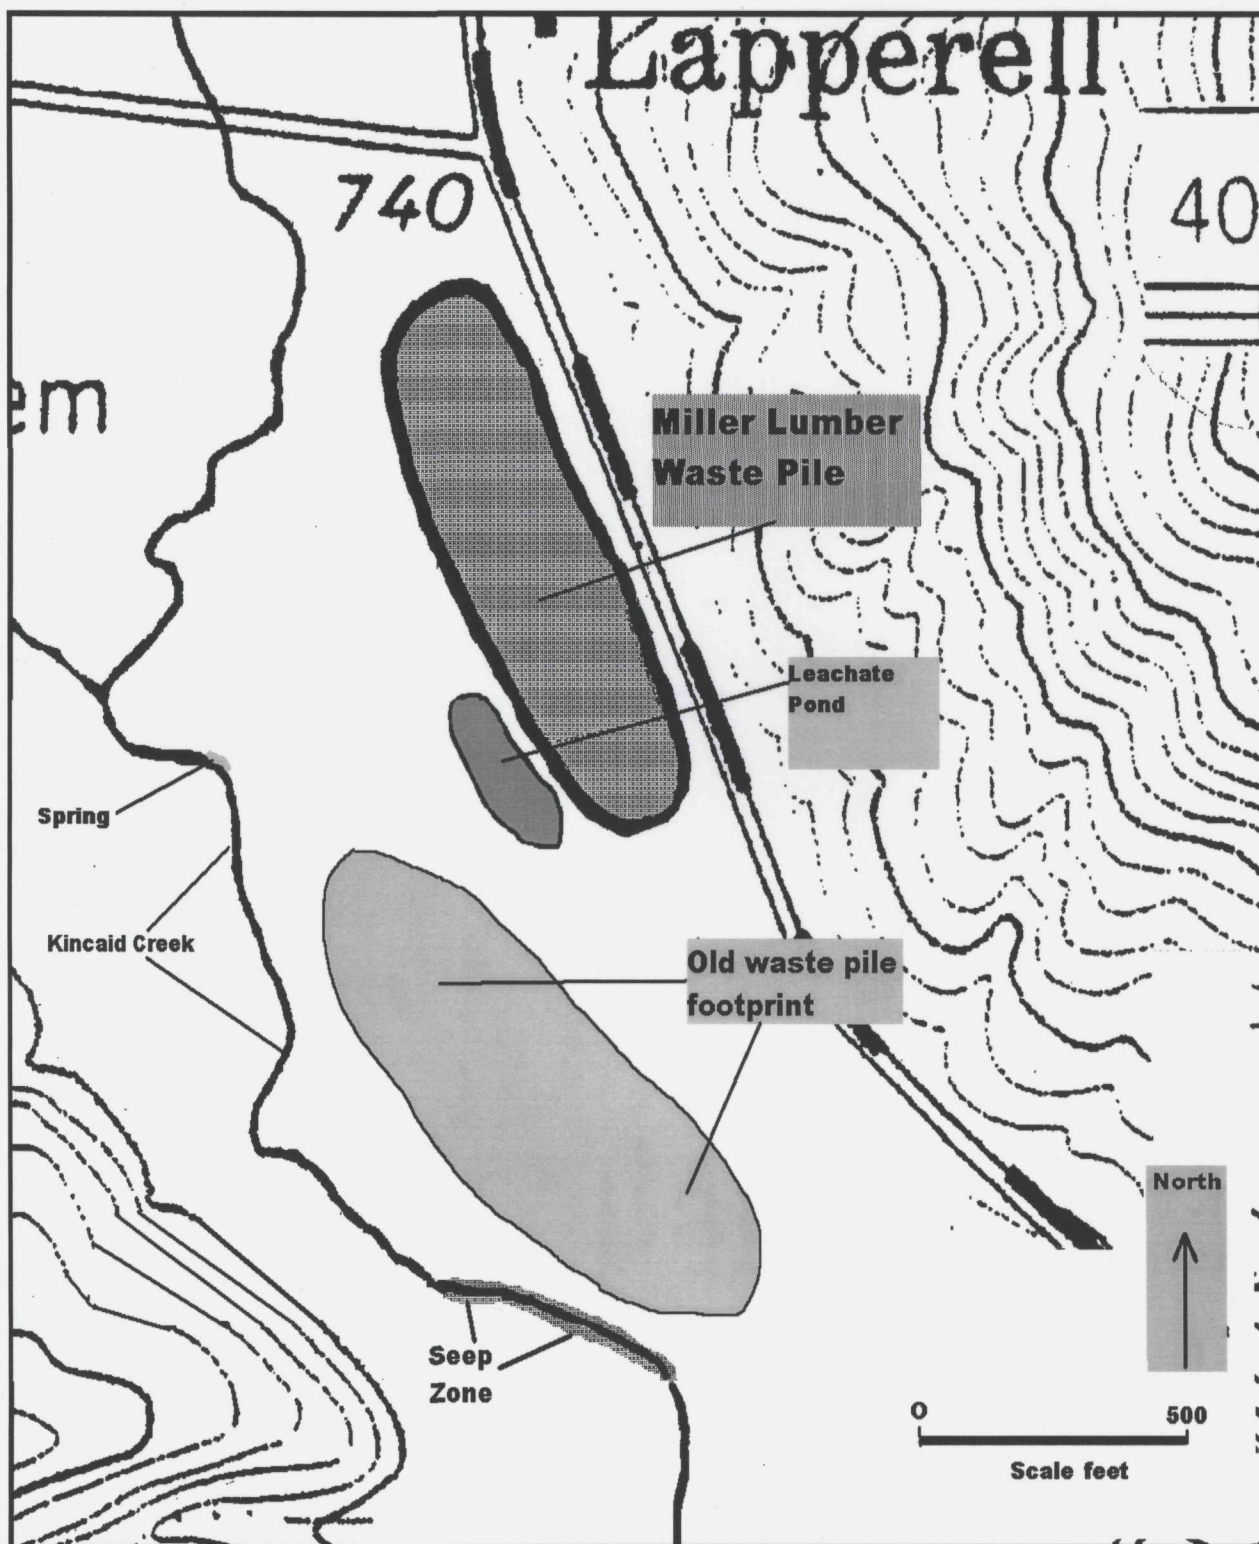
Figure 2 - Map of the Miller Lumber site showing the current waste pile, the old waste pile and the leachate pond relative to Kincaid Creek.

When the release ~~was~~ occurred at Miller Lumber, the fish hatchery noted that the spring water turned dark in color and took precautions to protect the fish stock at the hatchery. Along Kincaid Creek near the Miller Lumber site, there are seeps on the east stream bank. The seeps have an orange-red to black discoloration. One prominent zone of seepage occurs along Kincaid Creek near the old waste pile footprint. It is estimated that this seep encompassess approximately 200 feet of stream bank (Figure 2).

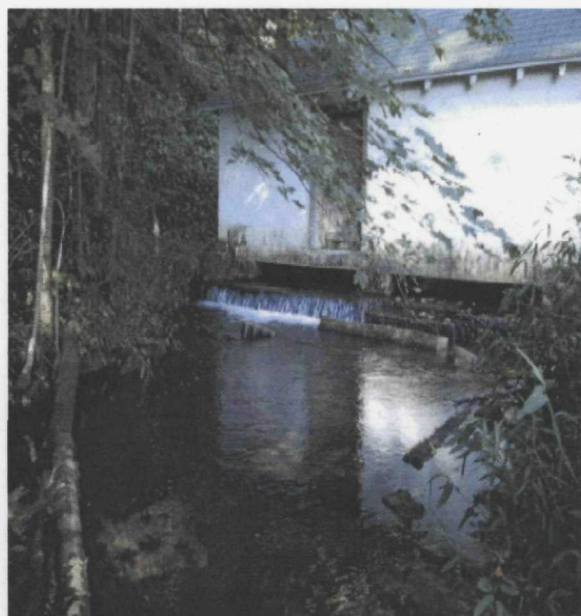
Figure 5 - Kincaid Springs.

Approximately 1.5 miles downstream of the Miller Lumber site is the Kincaid Spring (Figure 5). This spring flows between 1900 gpm to 5000 gpm and is used as the only water source for the ODNR Kincaid Springs Fish Hatchery. Residents living in the Mifflin Township area also use the spring for drinking water due to a high hydrogen sulfide content in private wells.

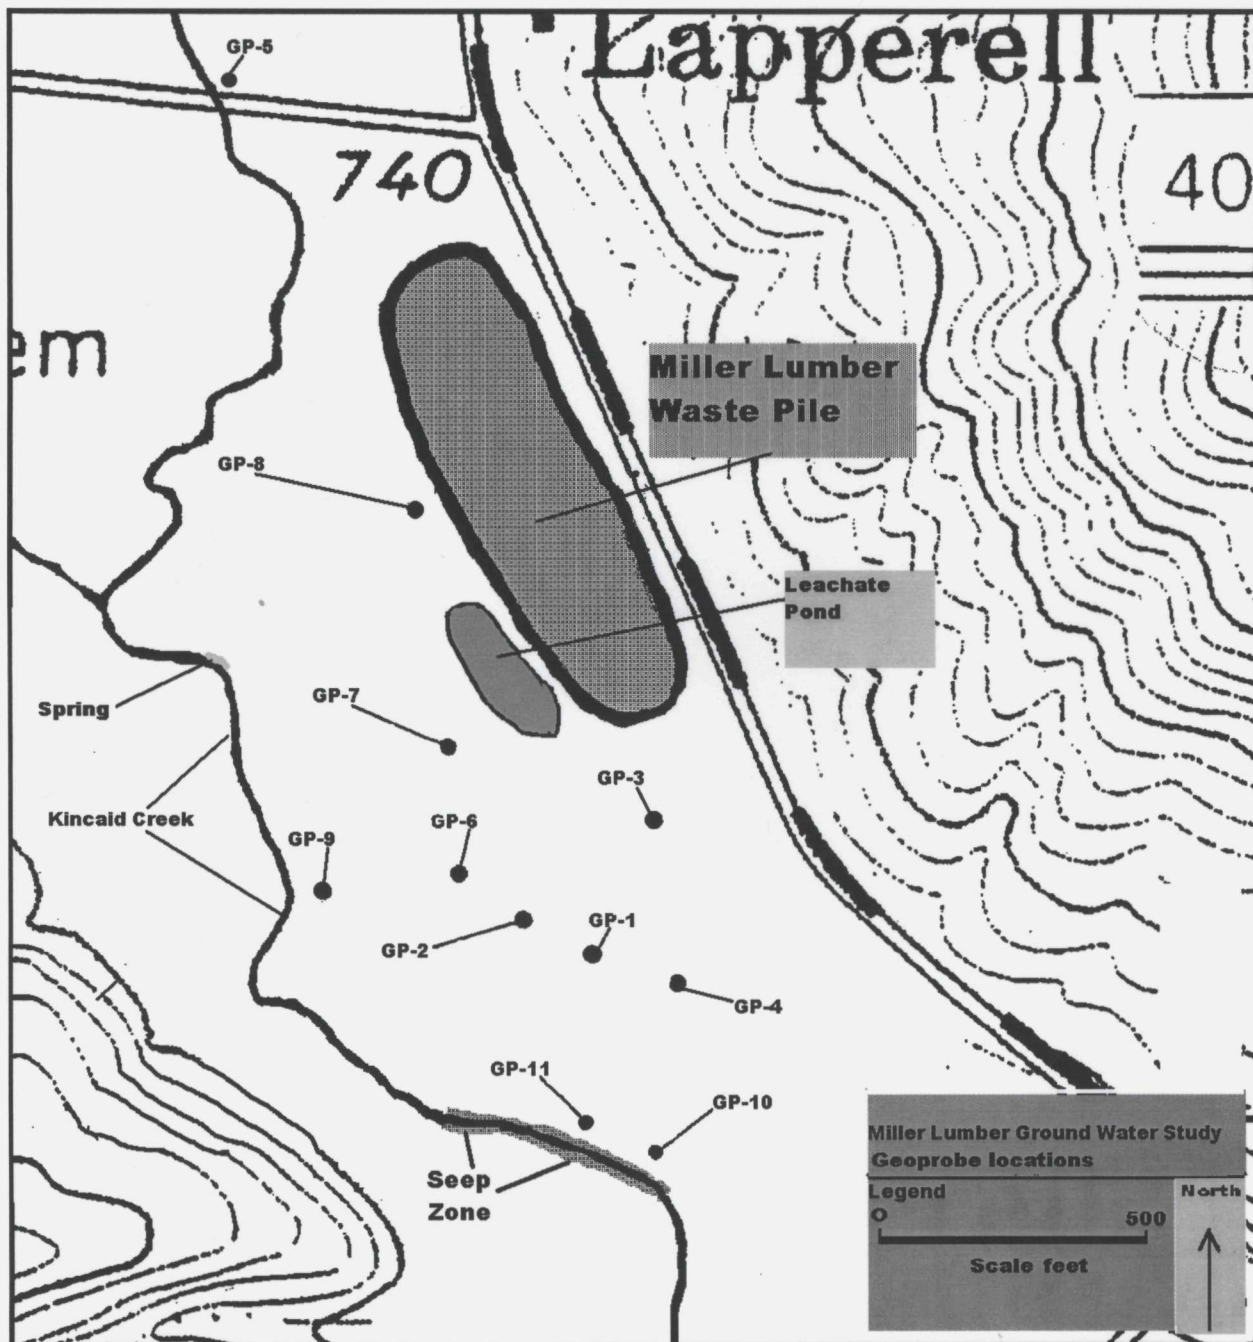
Figure 8 - Geoprobe locations where ground water was collected during the November 2003 investigation.
